**ACCIDENT**

<b>Aircraft Type and Registration:</b>	Silence Twister, G-TWST
<b>No &amp; Type of Engines:</b>	1 Jabiru 2200A piston engine
<b>Category:</b>	1.3
<b>Year of Manufacture:</b>	2004
<b>Date &amp; Time (UTC):</b>	27 February 2005 at 1256 hrs
<b>Location:</b>	Aylesbury (Thame) Airfield, Buckinghamshire
<b>Type of Flight:</b>	Private
<b>Persons on Board:</b>	Crew - 1                      Passengers - None
<b>Injuries:</b>	Crew - 1 (Serious)      Passengers - N/A
<b>Nature of Damage:</b>	Landing gear collapsed, engine and front cowling detached, broken propeller blades, damage to aircraft underside
<b>Commander's Licence:</b>	Private Pilot's Licence
<b>Commander's Age:</b>	38 years
<b>Commander's Flying Experience:</b>	420 hours (of which 5 were on type) Last 90 days - 5 hours Last 28 days - 4 hours
<b>Information Source:</b>	Aircraft Accident Report Form submitted by the pilot and further enquiries by the AAIB

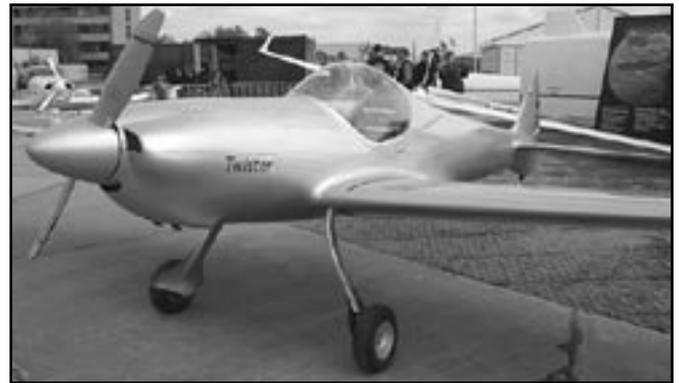
**Figure 1**

Silence Twister

The Silence Twister (as shown, Figure 1) is a light weight, all-composite, low-wing, kit-build aircraft with a tailwheel configuration and retractable main gear. It has a maximum take-off weight of 420 kg and is powered by a four-cylinder, four-stroke Jabiru 2200A engine, driving a fixed pitch propeller. The aircraft has a fuel tank within the inboard section of each wing with a combined total fuel capacity of 80 litres.
