ACCIDENT

Aircraft Type and Registration:	Team Minimax 93, G-CBPL	
No & Type of Engines:	1 x Mosler CB 40 piston engine	
Year of Manufacture:	2002	
Date & Time (UTC):	18 May 2012 at 1720 hrs	
Location:	Field adjacent to Newnham Way, Ashwell, Herts	
Type of Flight:	Private	
Persons on Board:	Crew - 1	Passengers - None
Injuries:	Crew - 1 (Serious)	Passengers - N/A
Nature of Damage:	Aircraft destroyed	
Commander's Licence:	UK CAA Private Pilot's Licence (Aeroplanes)	
Commander's Age:	62 years	
Commander's Flying Experience:	363 hours (of which 0 were on type) Last 90 days - 2 hours Last 28 days - 0 hours	
Information Source:	AAIB Field Investigation

Synopsis

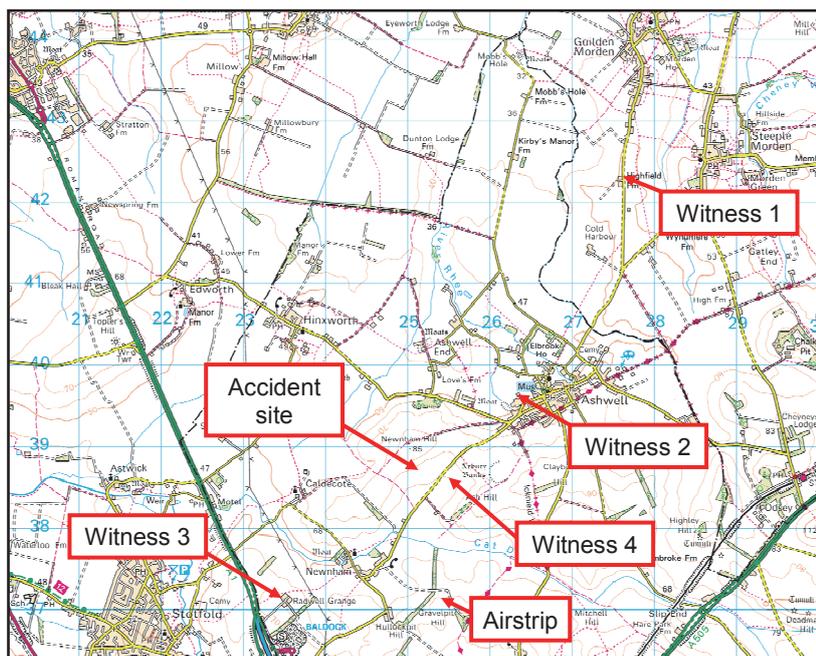
Figure 1

Local area map showing, eyewitness locations, etc

Several eye witnesses (see Figure 1) may have seen the aircraft before the accident. Two witnesses (witnesses 1 and 2) saw an aircraft flying near the airstrip close to

the time of the accident flying at a relatively low height, but straight and level, with the engine sounding “rough” or unusual. Witnesses 3 and 4 saw the aircraft’s final manoeuvre, describing an aircraft descending in an erect spin to the left.
