Report on the investigation of the
loss of the fishing vessel
Meridian KY147
with the loss of four crew
160nm due east of Aberdeen
on 26 October 2006

**Report No 20/2007
September 2007**

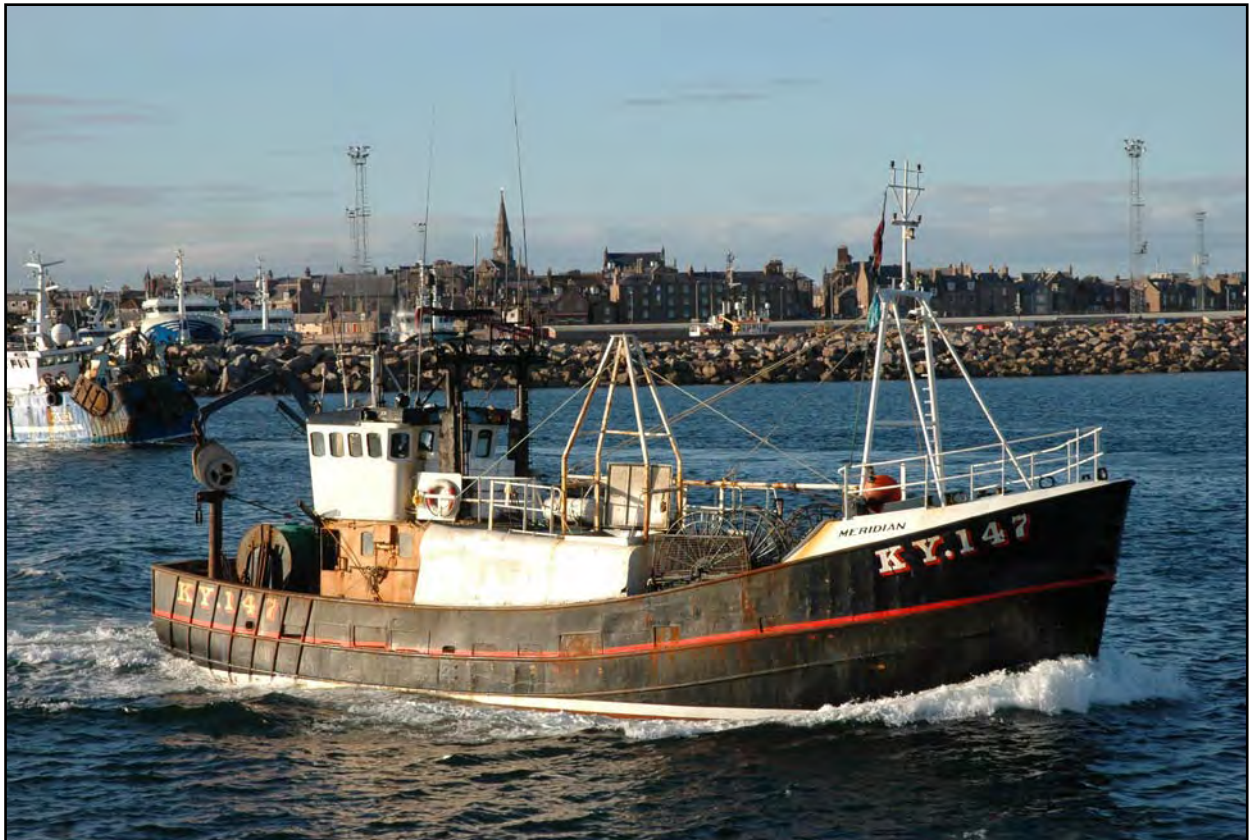
Figure 1

Meridian

1.1 PARTICULARS OF *MERIDIAN* KY147 (Figure 1) AND ACCIDENT

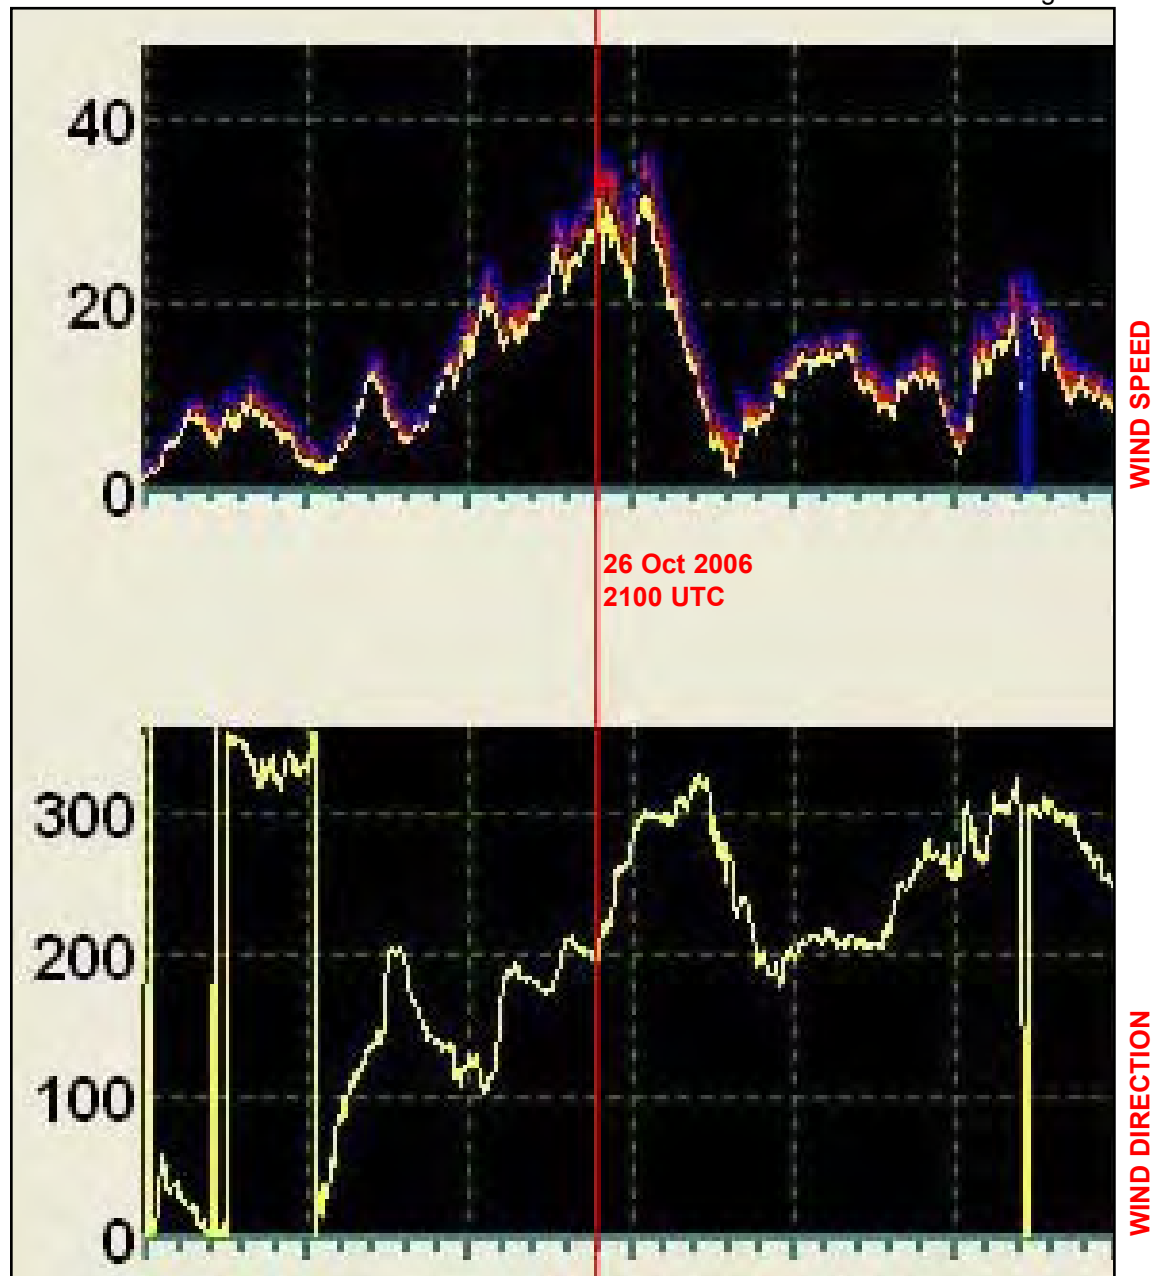
Figure 7

ULA platform weather data

The weather data recorded by the nearby Ula platform (at the height of the platform) showed a continual pressure drop from 1000Mb on 25 October to eventually 974Mb on the evening of the 26th. Wind speeds consequently increased from 12m/s (Force 6) from south-east to peak at a maximum of 36m/s (Force 12) from south-west on the evening of the 26th (**Figure 7**).
