Report on the
abandonment and subsequent sinking
of the Motor Vessel

IRVING FOREST

in the North Atlantic Ocean
in January 1990

Marine Accident Investigation Branch
5/7 Brunswick Place
SOUTHAMPTON
Hants SO1 2AN

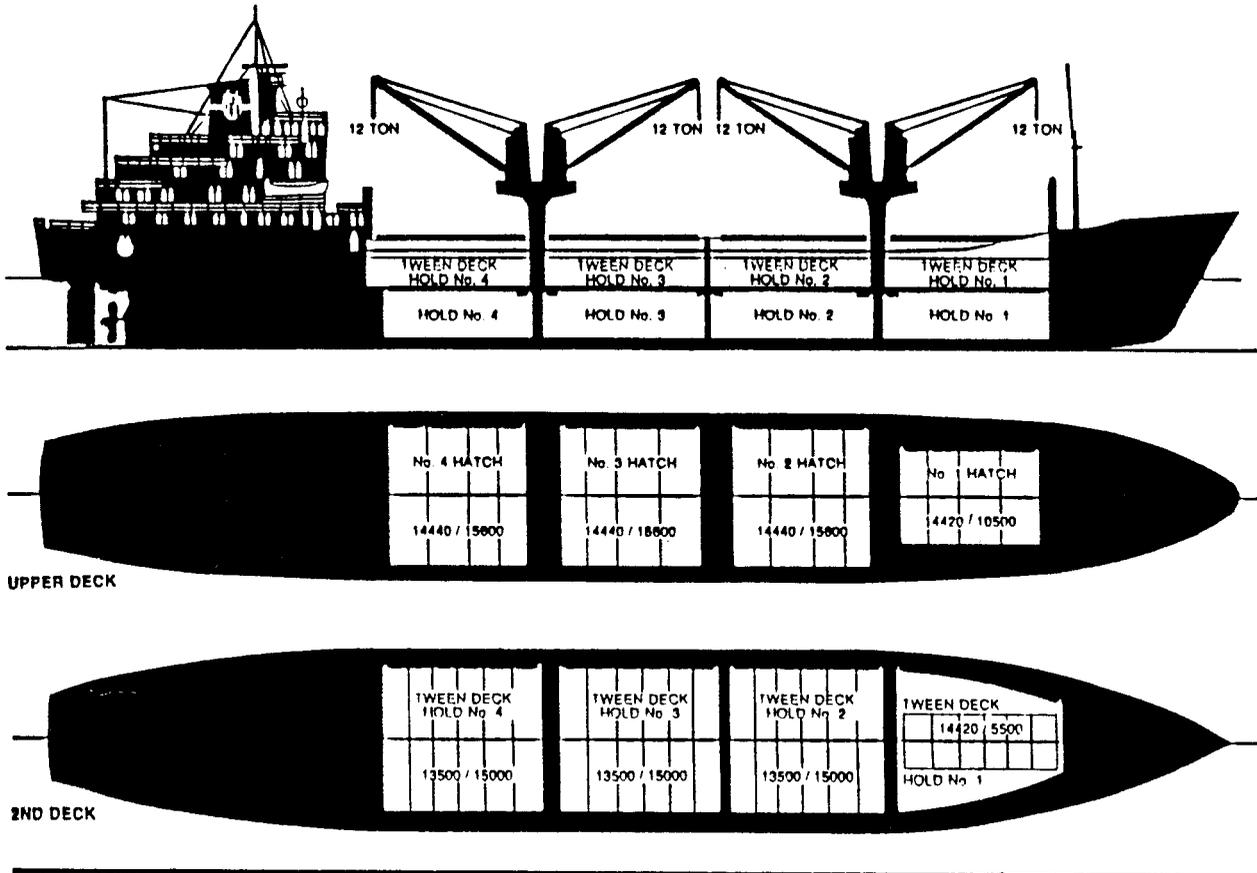
M.V. IRVING FOREST

MAIN PARTICULARS

Tonnage:
 Full scantling vessel 6 618.47 GRT
 2 956.12 NRT
 Freedecker 3 686.41 GRT
 1 447.82 NRT

3 self-tensioning el-hydraulic mooring winches
 8 t pull.
 El-hydraulic four-ram steering gear
 2 twin cargo cranes 12/24 t @ 18.5 m
 Air conditioning/heating
 CO2 and fire detecting system in holds
 10 reeler plugs on deck

Page
Section 1	: Introduction	1
Section 2	: Vessel Details	2
Section 3	: Condition of vessel on sailing	4
Section 4	: Narrative	6
Section 5	: Discussion	11
Section 6	: Findings	16
Figure 1	: IRVING FOREST	17
