ACCIDENT

Aircraft Type and Registration:	Airbus A321-211, G-DHJH
No & Type of Engines:	2 CFM56-5B3 turbofan engines
Year of Manufacture:	2000
Date & Time (UTC):	17 February 2008 at 1527 hrs
Location:	Manchester Airport
Type of Flight:	Commercial Air Transport (Passenger)
Persons on Board:	Crew - 7 Passengers - 220
Injuries:	Crew - None Passengers - None
Nature of Damage:	Nose landing gear damaged
Commander's Licence:	Airline Transport Pilot's Licence
Commander's Age:	55 years
Commander's Flying Experience:	18,000 hours (of which 7,000 were on type) Last 90 days - 150 hours Last 28 days - Not known
Information Source:	AAIB Field Investigation

Synopsis

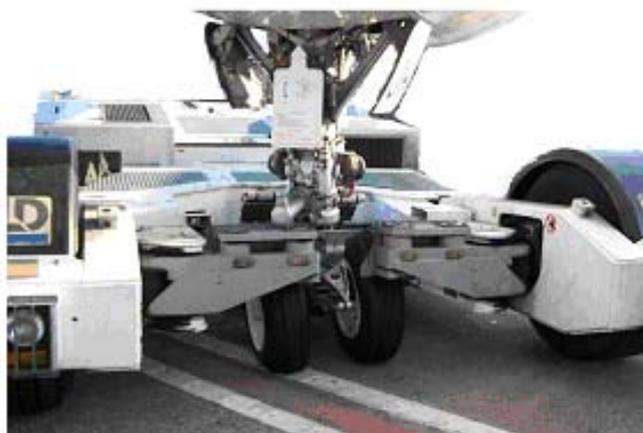
Figure 1

The operator's engineers found that the nosewheels had fallen from the towbarless tug's hydraulic-powered

‘grab and retention’ mechanism and were in contact with the apron surface (Figure 1). Both of the nosewheel steering motors mounted on the landing gear leg had been damaged by the tug’s structure, which required the complete nose landing gear to be changed prior to the next flight.

Nosewheels after falling from the ‘grab and retention’ mechanism (looking forward)

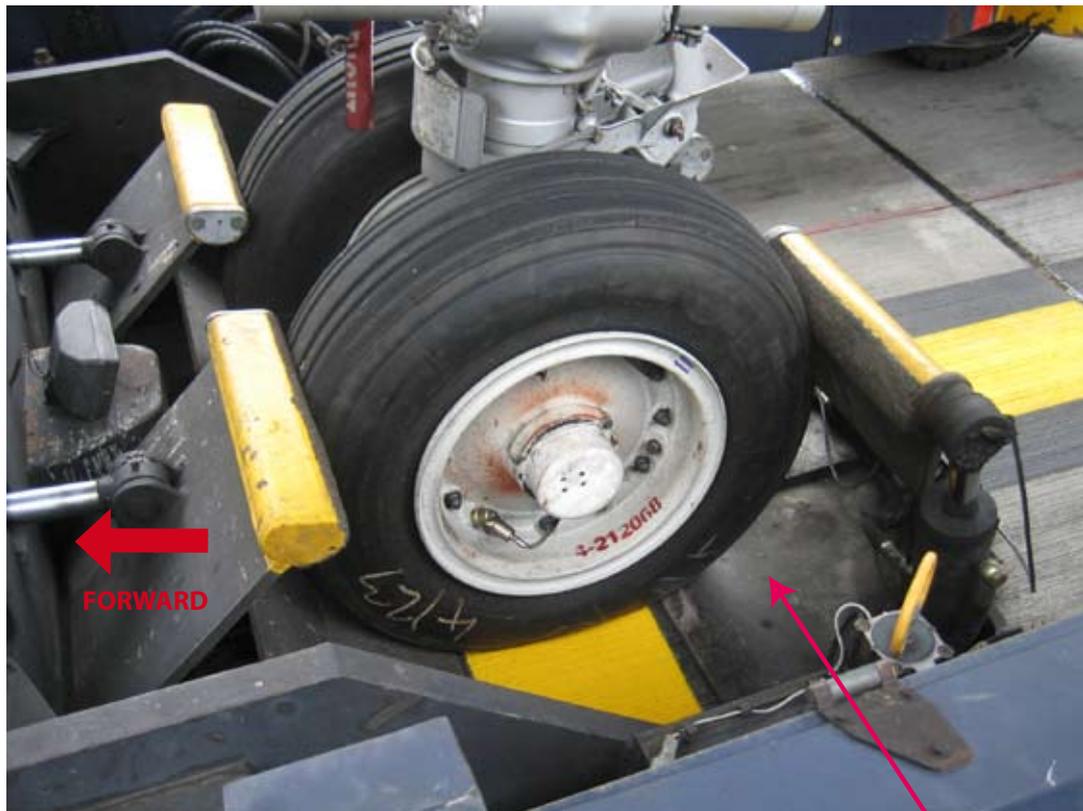
Figure 2

Inspection of another manufacturer’s towbarless tug found that it had a safety feature that would not allow the aircraft nosewheel tyres to contact the ground if the

hydraulic ‘grab and retention’ mechanism released the tyres whilst manoeuvring an aircraft (Figure 2).

Wheel retention plates

Another manufacturer's towbarless tug
