AIRCRAFT SURVEY REPORT

REGISTRATION: G-ARLX TYPE: HUGHES 269C SERIAL NO: 900041

**LETTER TO OWNERS/OPERATORS NO
SCHWEIZER (HUGHES) 269A, 269A-1, 269B, 269C AND 269C-1 SERIES HELICOPTERS
FAILURE OF TAILBOOM FITTING ATTACHMENT LUG**

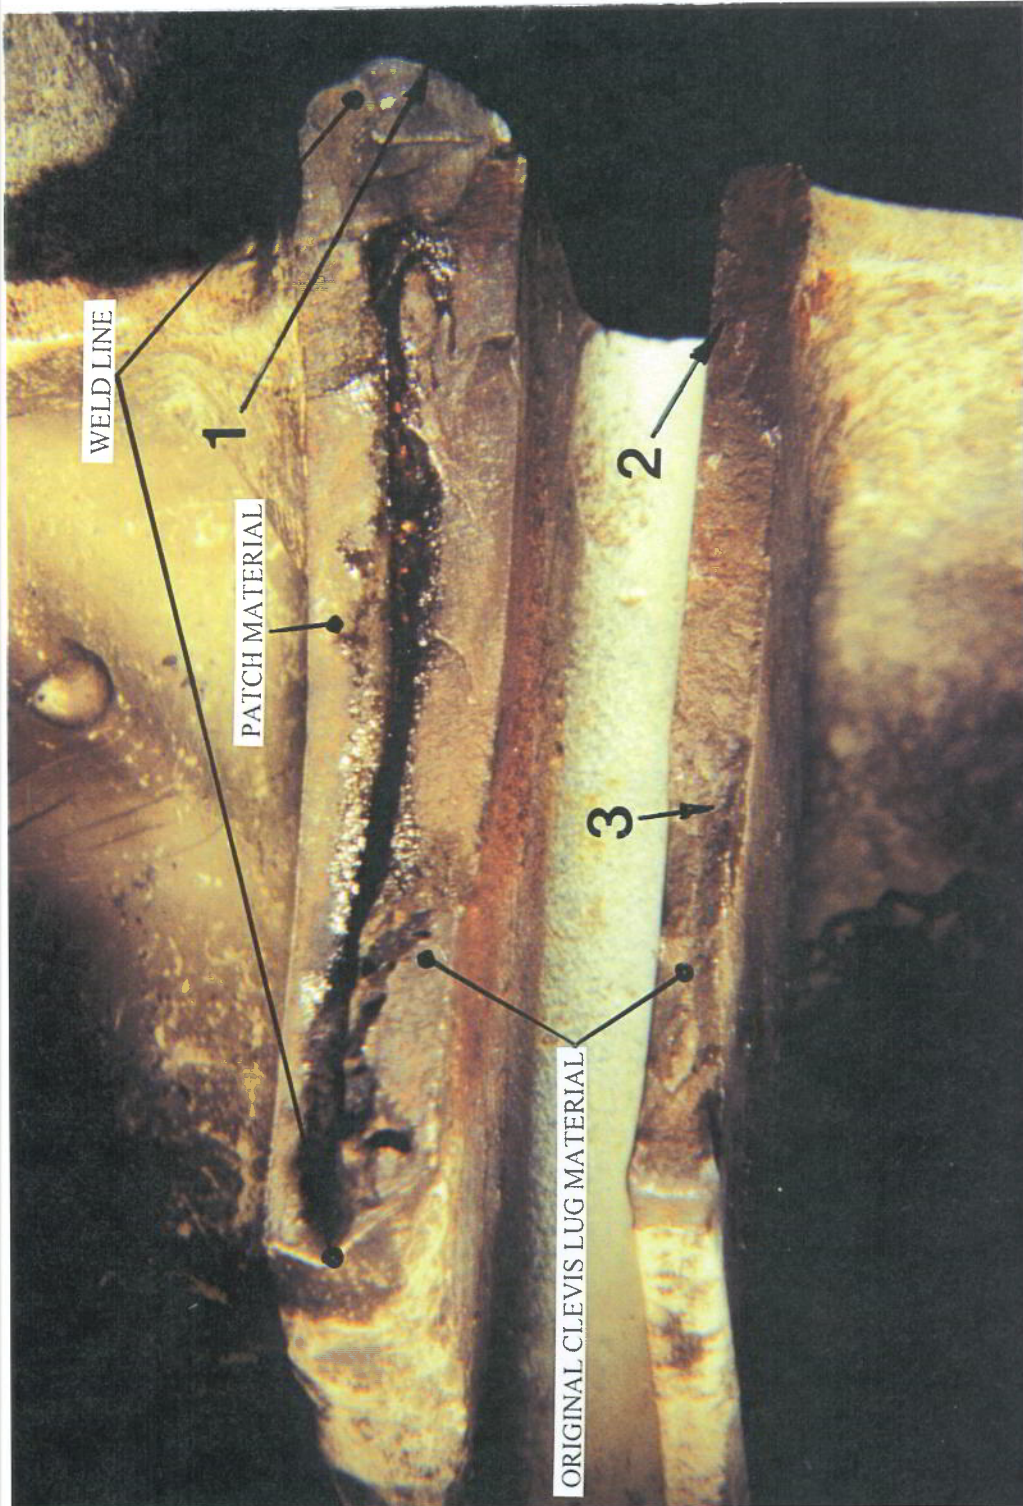
Photograph 1

Enlarged view of the forward fracture faces on the left Centre Frame Rear Cluster Fitting after solvent cleaning. Separation had resulted from a very high cycle tension fatigue mechanism that had initiated along the edge marked 1. A secondary initiation was present in the area marked 2. Overload tearing had started in the area marked 3 which led to the final separation.

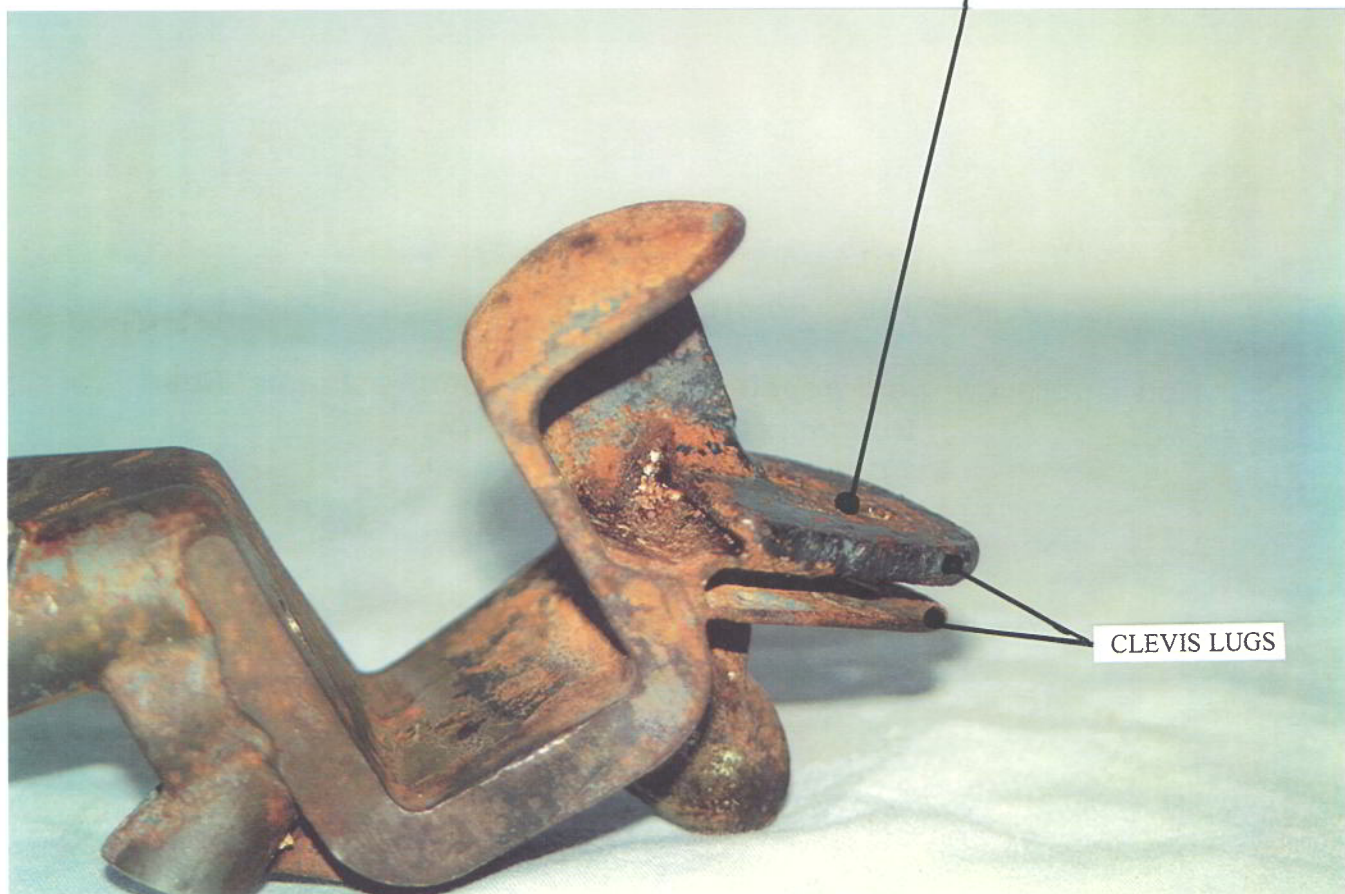
Photograph 4

Non approved welded patch repair to the right Centre Frame
Rear Cluster Fitting of G-BPPY
