Carbon monoxide poisoning on board the scallop-dredger *ESHCOL* in Whitby, North Yorkshire on 15 January 2014 resulting in two fatalities

MAIB SAFETY BULLETIN 1/2014

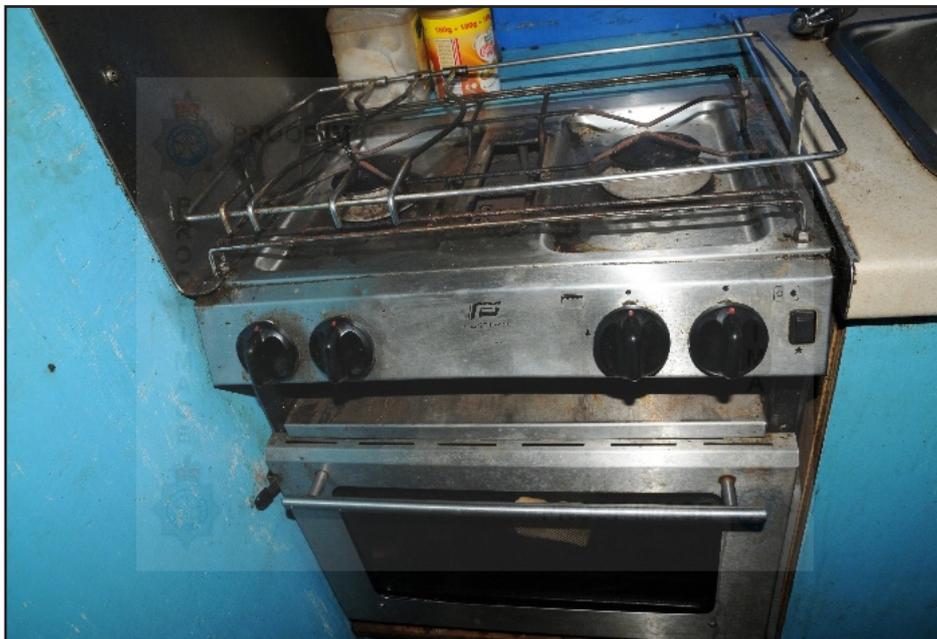
Figure 1

Before going to bed, the skipper (aged 26) and the crewman (aged 21) had lit the grill of a butane gas cooker fitted in the wheelhouse (**Figure 1**) in order to warm both the wheelhouse and the adjacent sleeping area. When they were not seen as expected the following morning, crewmen from fishing vessels tied up close by forced open the wheelhouse door. The gas grill was still lit (**Figure 2**) and the wheelhouse was full of fumes; the two men were dead in their bunks.

1. Gas cookers are designed for cooking, not domestic heating. Accommodation areas need to be heated, especially during the winter months and, for this, appropriate, purpose built heaters are required.

4. Carbon monoxide alarms are not expensive and should be fitted. When selecting a carbon monoxide alarm, preference should be given to those marked as meeting safety standard EN 50291-2:2010, which are intended for use in a marine environment.

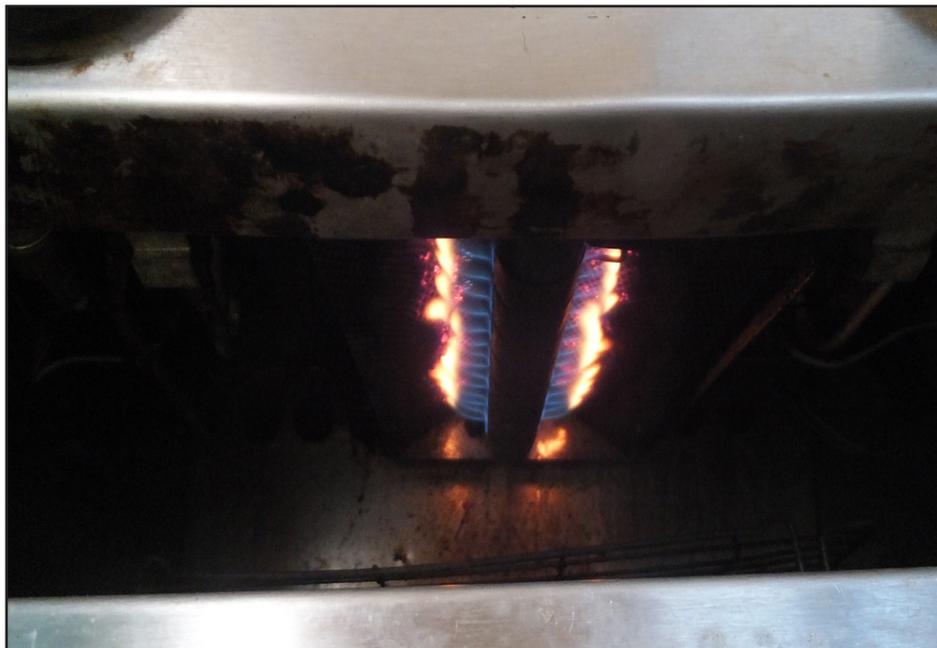
Figure 2

2. Fossil fuel burning appliances, such as cookers, need to be checked and maintained to ensure they are in good condition. A yellow flame indicates poor combustion, resulting in an excess of carbon monoxide that, in a poorly ventilated space, can quickly build up to lethal levels.
